INVESTIGATION ON ORIENTATION OF PILES IN PILE CAPS

Abstract— Piles constitute the most extensively used deep foundation for various kinds of structures. A column is supported by 1,2,3,4 or many piles to resist forces coming from the column. The important structural member, pile cap, between the column and the piles, transfers forces coming from the column to the piles. Of the various forces acting on the pile cap, flexural shear constitutes most involved force. Indian national code IS 456 : 2000 specifies, when flexural shear force occurs on the pile cap for the given forces on the column and developing reactions from the piles and their orientation. Two pile caps were tested in the current experimental study to investigate the validity of the codal provisions relative to occurrence of shear force on pile cap. One pile cap had four piles at the four corners of a square. For comparison, second pile cap had four piles at the four corners of a rhombus. Comparisons were made between the orientations of pile arrangement. Both the pile caps failed in flexure, validating the codal provisions. The experimental research validates the provisions of IS 456 : 2000 code relative to occurrence

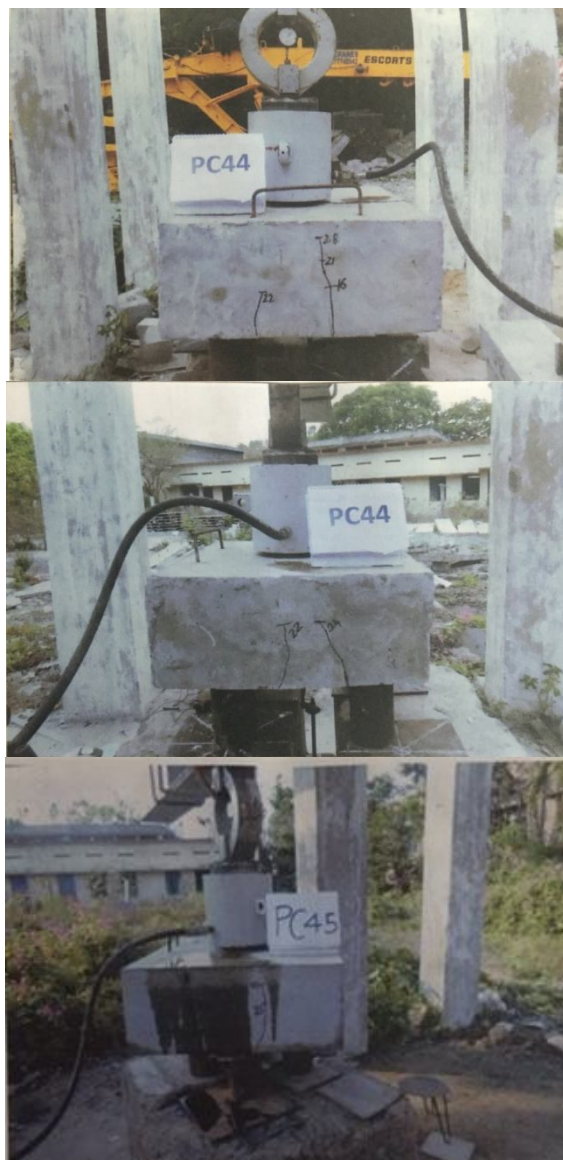
The current investigation is undertaken to test two identical pile caps. The only variable is location of piles. In one pile cap, piles were located at the four corners of a square. In the second one, piles were located at the four corners of a rhombus. The test results of the two pile caps were compared. Two numbers of identical four pile caps were taken for investigation in the present work. The piles are designated as PC 44 and PC 45. The moulds for the four pile caps are made with brick masonry and plastered smooth. The four pile cap PC 44 was designed to examine whether it fails in flexure, by placing the piles in such a position, shown in Figure 3.1(a). The depth of pile cap PC 44 was 250mm. As

per the code, both the pile caps were designed to fail in bending. Pile cap PC 45 orientation is shown in Figure 3.1(b). The concrete for the pile caps was prepared in the laboratory with a concrete mixer. The concrete was placed in the pile cap mould and was compacted with a needle vibrator. The control specimen cubes and cylinders were compacted in a standard way. Curing of specimens was done with wet gunny bags in the lab environment. At the termination of curing, pile caps were made ready for testing. The pile caps were tested in a load frame shown in Figure 3.2.

The properties of test specimens are provided in Table 3.1. The properties of reinforcement used in the pile caps are tabulated in Table 3.2. The details of test specimens are illustrated in Figures 3.1(a) and 3.1(b). The pile caps were tested to failure in several load increments. As the ultimate load approached, load increment was reduced. The time for testing to failure took about two hours. At each load stage, load applied, the resulting deflection and maximum crack width were measured.

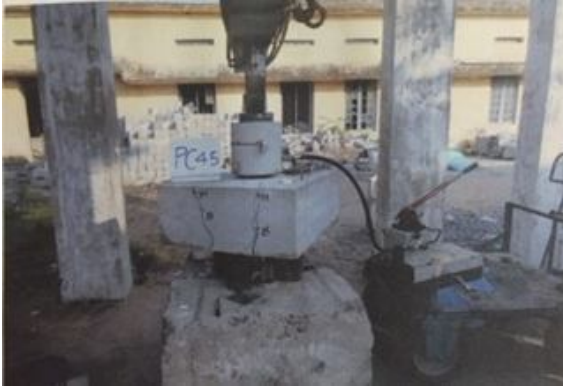
The test specimens were instrumented to obtain the measurements of transverse load, deflection at the centre of pile cap and crack widths. A dial gauge with a least count of 0.01mm positioned, at the centre of pile cap, was employed to capture the load deflection response. A hand held microscope, capable of measuring a minimum value of 0.05mm was used to record crack growth development. A hydraulic jack of 1000kN and a proving ring of 1000kN capacity were used for load application and load measurement respectively.
